Class B-1 Response Action Outcome Partial Statement for 20 Franklin Avenue, Somerville, Massachusetts

50 Tufts Street Site, Somerville, Massachusetts

December 17, 2012

Project 04516-3

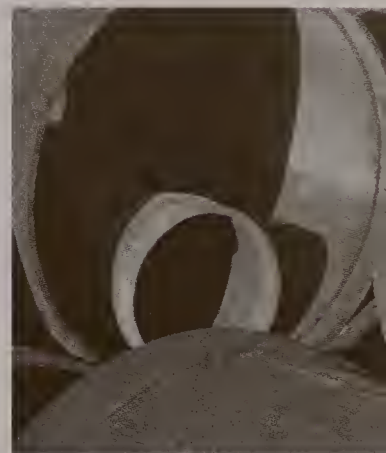
Fig. 2

GEI developed this Conceptual Site Model (CSM) to describe release mechanisms, contaminant distribution, and potential exposure pathways associated with the Property. The CSM is based upon the investigation data documented in the Phase II/III and the IRAC Report. Site features associated with the CSM are shown in Fig. 2.

For a Method 1 Risk Characterization, and in accordance with 310 CMR 40.0924, “the groundwater EPC shall be the groundwater resource itself, as measured at each wellhead...” Therefore, the maximum groundwater concentrations for each COPC in monitoring wells MW121S and MW121D were identified as EPCs (Table 4). The locations of groundwater monitoring wells MW121S and MW121D are shown in Fig. 2.
